## ■ Fault symptom

A KX11 vehicle TCM malfunction, but after replacing the new TCM spare part and reloading the software, the vehicle was unable to display PDRN gear indicators and vehicle could not start.

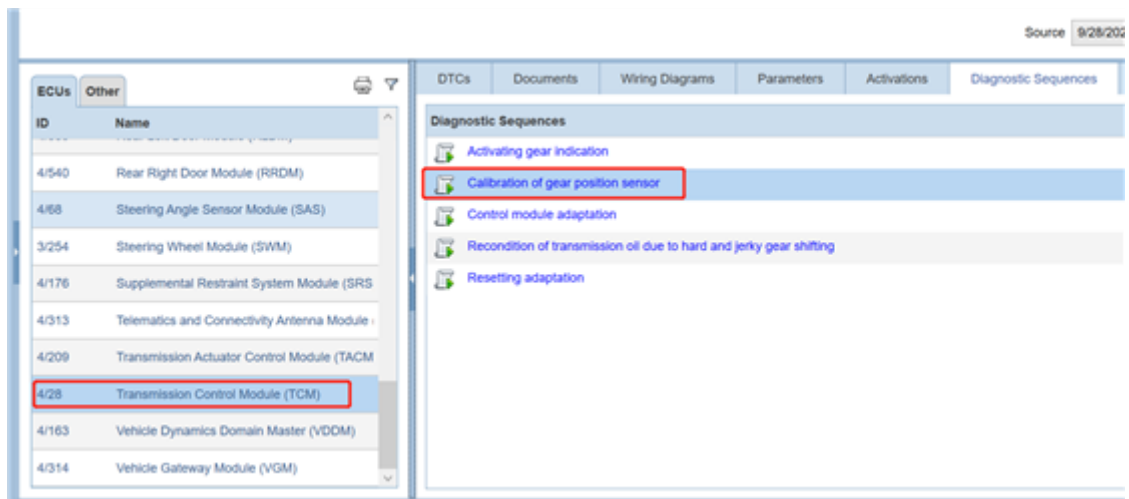
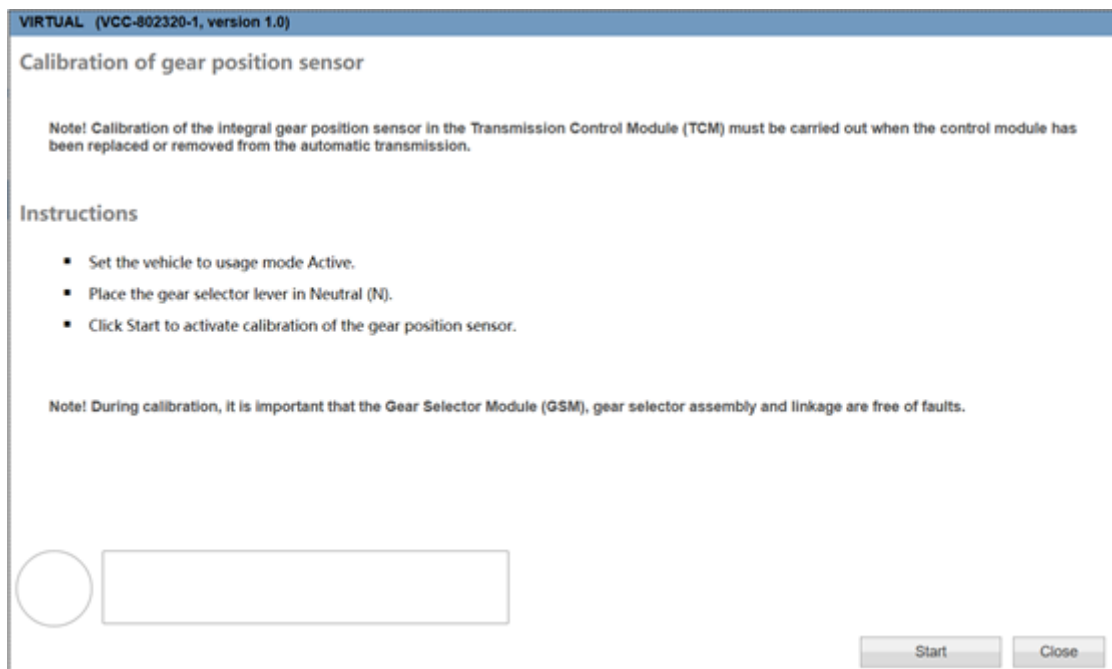
1. First confirmed the fault performance and the new TCM module software reloaded successfully.
2. Confirmed with the workshop technician that he didn't make the gear position calibration operation. Tried to make the gear position calibration as the following steps but failed and calibration process couldn't pass successfully.

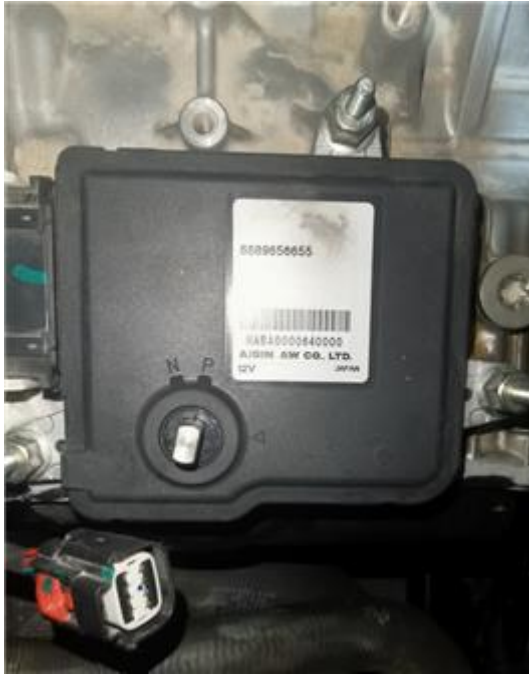
3. The root cause of this problem could be confirmed that the new spare part TCM could not complete the gear position calibration. Further reviewing the instructions of the gear position sensor calibration, found it need to place the gear selector lever in N. However, after removing the TACM (transmission actuator control module) , which is installed on the top of the TCM, it was found that the marked position of the TCM was not aligned and the groove hole position was facing P gear.

When the W/S replaced the TCM, the car was in P gear and turned off status, so when they installed the TCM spare part, the TCM marks could not be aligned, and could not meet the gear position calibration conditions N gear requested. The spare part TCM could not complete the gear position calibration caused this problem.

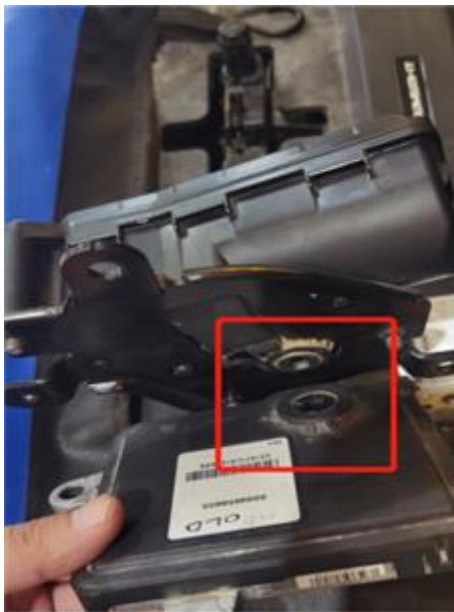
4. From the structure , if the groove position of the TCM was facing P , indicating that the rotary shaft and the hole of the shift actuator ( TACM ) would also in the P position.

In view of this, reinstalled the old TCM (with the groove facing P), started the vehicle, engaged the EPB, shifted to N gear, after that, long pressed the SSB switch to turn off the engine (note: in N gear, short pressing the SSB switch cannot turn off the engine), and then remove the TACM and the old TCM.
