■ Fault symptom

Customer could not find radio stations when searching automatically. However, everything worked well while searching manually. After adding manually found radio stations to favorites and switching to the next wave, the multimedia skipped favorite radio stations, and finally no stations had been found.

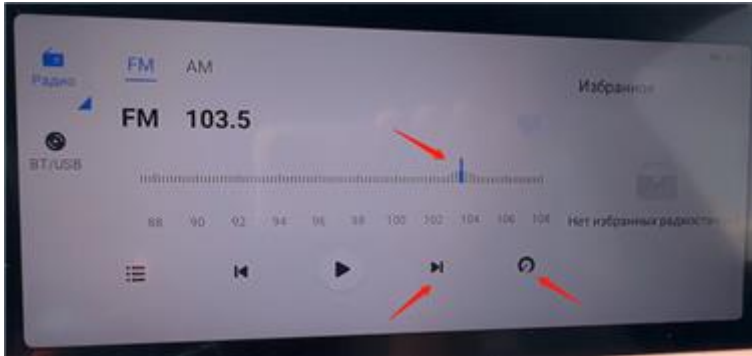
1. Confirmed the fault phenomenon.

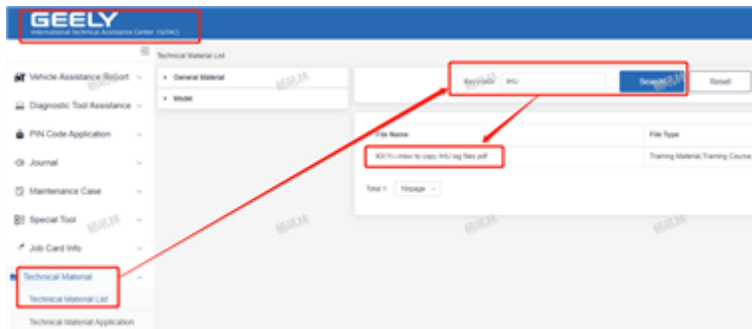
2. Since it was a fault of MMI, we need to copy the IHU log for analysis. Copied IHU log and recorded the time when the fault occurred. There was an operation method on GITAC.

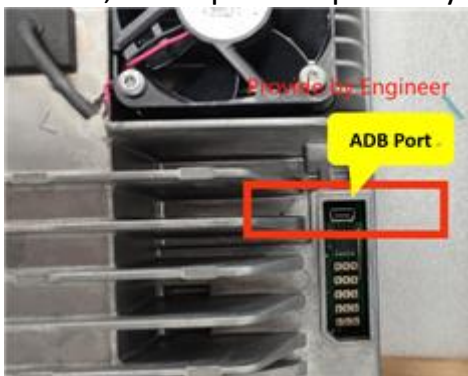
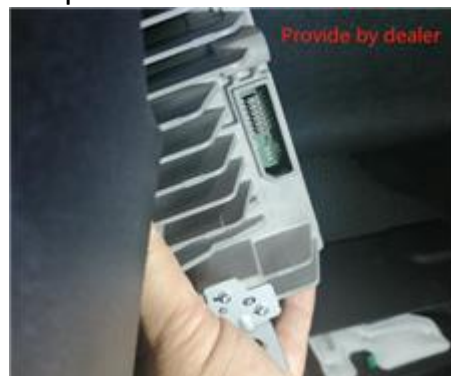
3. Unfortunately, due to software issues, the radio malfunction could not be located. The engineer decided to update the software specifically to catch faults. At first, we hoped to update by ADB port But there was no ADB port on the car.

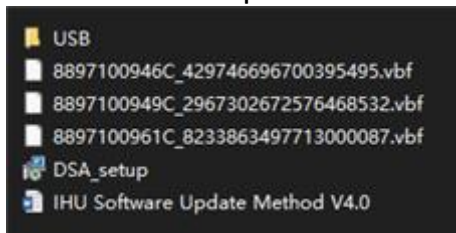
- Then we changed the method to DSA & USB Drive. There were 2 kinds of method which need to operate both.

- However, due to the complexity of the operation methods, the process of copying IHU log was not smooth. Thanks to the dealer for their repeated assistance, we got the log finally.
- The level of the local radio station in Minsk is relatively low, between 22 and 35, and the level filter set by the system is 43, which causes the malfunction.

- The engineer decided to reduce the level filter value to 20.

Update IHU software modified.
