■ Fault symptom

A KX11 vehicle had an engine overheating fault during PDI.

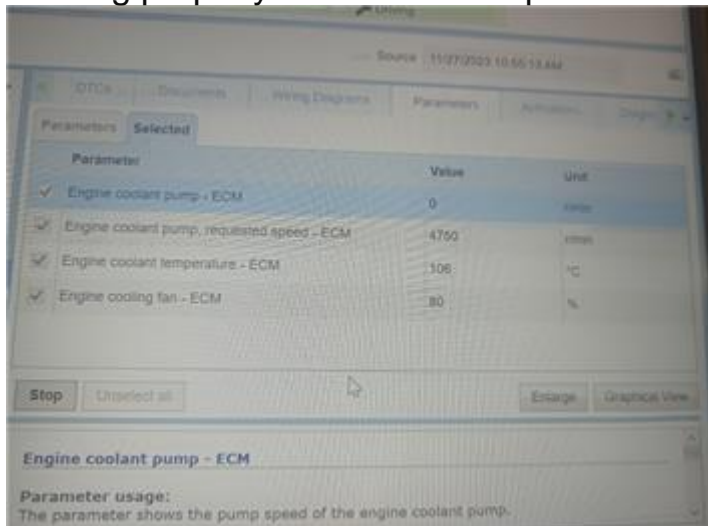
1. Upon inspection, it was found that the engine was not experiencing false overheating, but rather actual overheating. The technician checked the data stream of the EMS such as the actual speed of the water pump, target speed of the water pump, cooling fan speed, and coolant temperature data stream, and discovered that the fan is working properly but the actual speed of the water pump is 0.

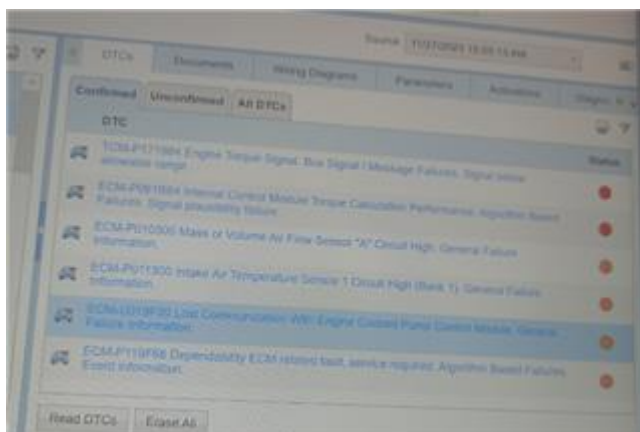
2. Read the fault codes and find that the water pump related fault codes U019F00, ECM lost communicate with coolant pump module
