■ Fault symptom

The rear mirror cannot be folded sometime in cold weather.

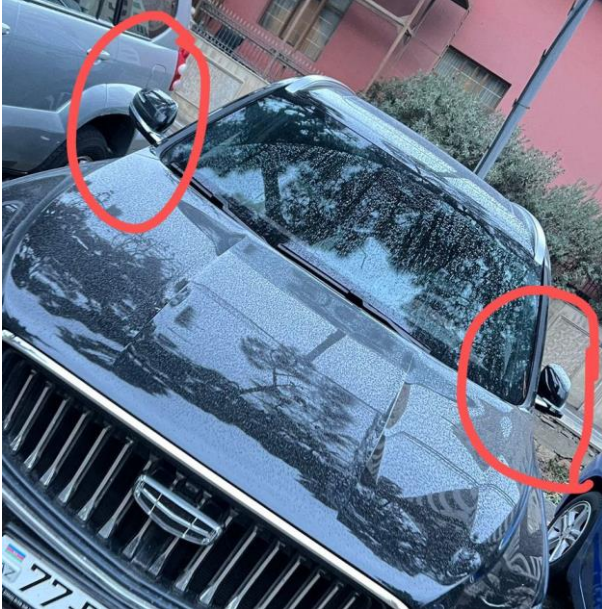
1. Confirmed the problem.

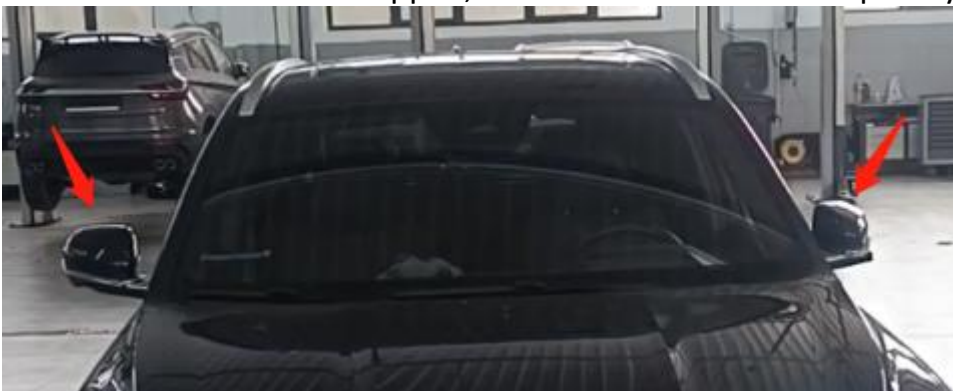
2. Drove the car to the workshop, the problem didn't occur.
3. At first, we thought the rearview mirror may have some water inside, then it froze in cold weather. However, after opening it and checking the wiring harness, everything is good. We tried to replace a new outside rearview mirror, the problem still occurred sometimes. And we also found that not just in snowy weather, but in cold weather (temperature more than 0°C).
4. We took a video of the problem and then discovered some details: the problem was not "cannot be folded", but "cannot be folded completely". One side just folded a little and then stopped, the other side folded completely.

5. Since the part is good, we thought that the cause maybe the software and confirmed with R&D. The reason is that, if the running current is greater than 70% of the starting current and the duration is greater than 300ms, the module will determine the stop position and then power off. The fault mainly occurs in winter. Due to the increase in motor operating current at low temperatures, the

folding process of the rearview mirror triggers a stop condition, and the control module loses power in advance, causing the folding to not be in place.

Upgrade the software of PDM and DDM on GLDS.
