## ■ Fault symptom

## ■ Fault diagnosis process

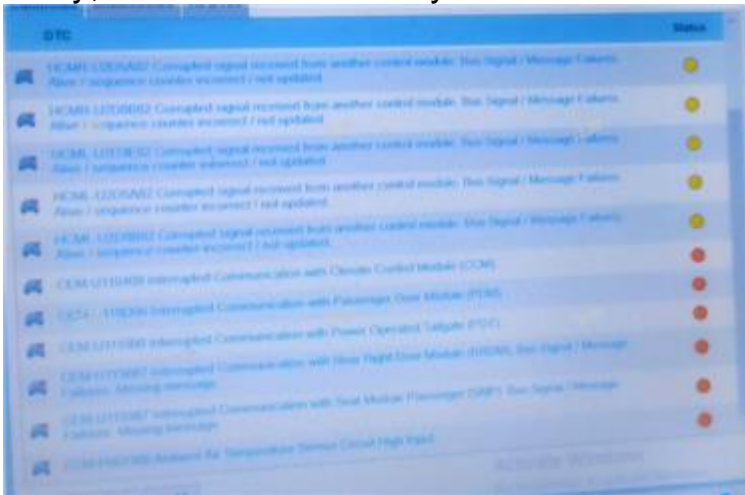
One customer reported that the air conditioner does not cool and can only blow warm air. The electric tailgate does not work and cannot be opened by remote. However, when the workshop inspected the vehicle, they found that the air conditioner was working normally, but the electric tailgate was faulty, and there were many fault codes in the system. As attached:

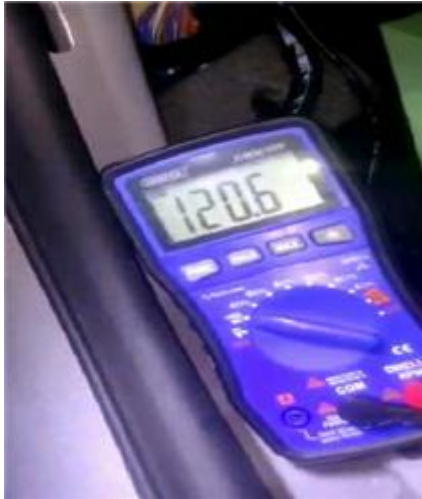
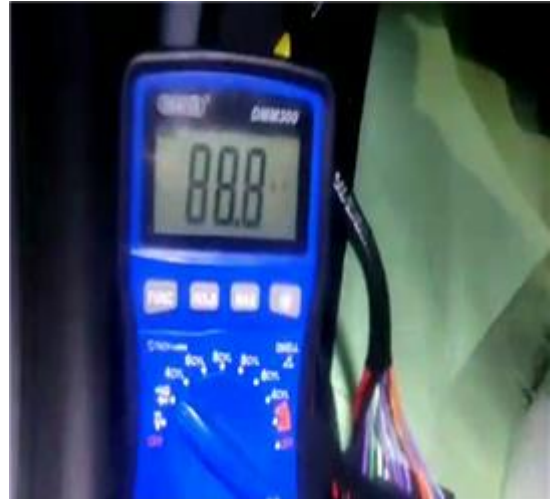
2. For further inspection, Let W/S disconnect the connector of 94/503 male and female side, and measure the resistance between pins 16 and 17 (to CEM) from the 94/503 male plug, then got 120 ohm resistance. However, the resistance between the sockets corresponding to 16/17 of 94/503 female terminal was 88K  $\Omega$ , indicating that there was an open circuit between 94/503 and CCM. The circuit needed to be further checked.

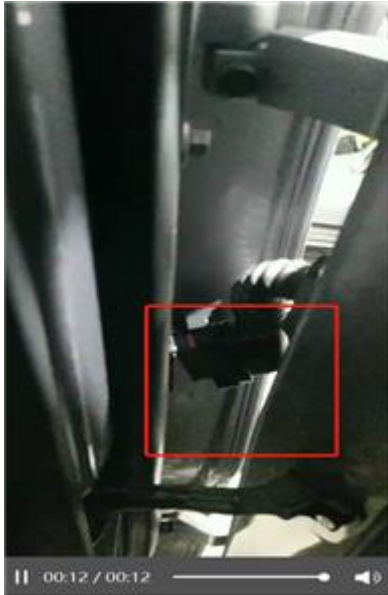
3. From the circuit diagram, it was planned to measure the resistance of the CAN system from 94/509 pin 14 and 15 to determine which part of harness has an open circuit. When the W/S found the 94/509 plug-in, it found that the plug-in was loose and disconnected. Which caused the CAN system was abnormal.

The open circuit of 94/509 plug leads to abnormal resistance of CAN system, which affects CCS /POT functions.

4. Plug and tighten the plug-in again. Problem solving.

Plug and tighten the plug-in 94/509 again. Problem solving.
